TCRA

Latest Trends in Tech Support

May 12, 2006

***Presented by;
Bob Warnke***

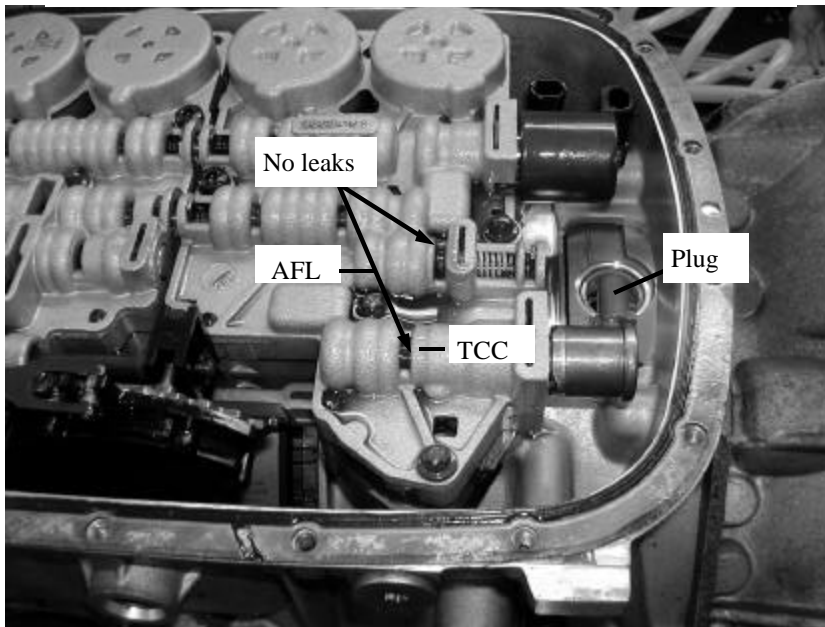
5L40E WAT

To isolate worn AFL bore and TCC regulator, a wet air test can be performed.

1. Unit **out of car**: Blow air into end of turbine shaft. Plug pump inlet hole. No leaks should be evident at either the TCC regulator or AFL. (photo)
2. Unit **in car**: Remove the line pressure tap. (passenger side front Torx head) Blow air into it. Plug pump inlet and place selector lever in reverse.

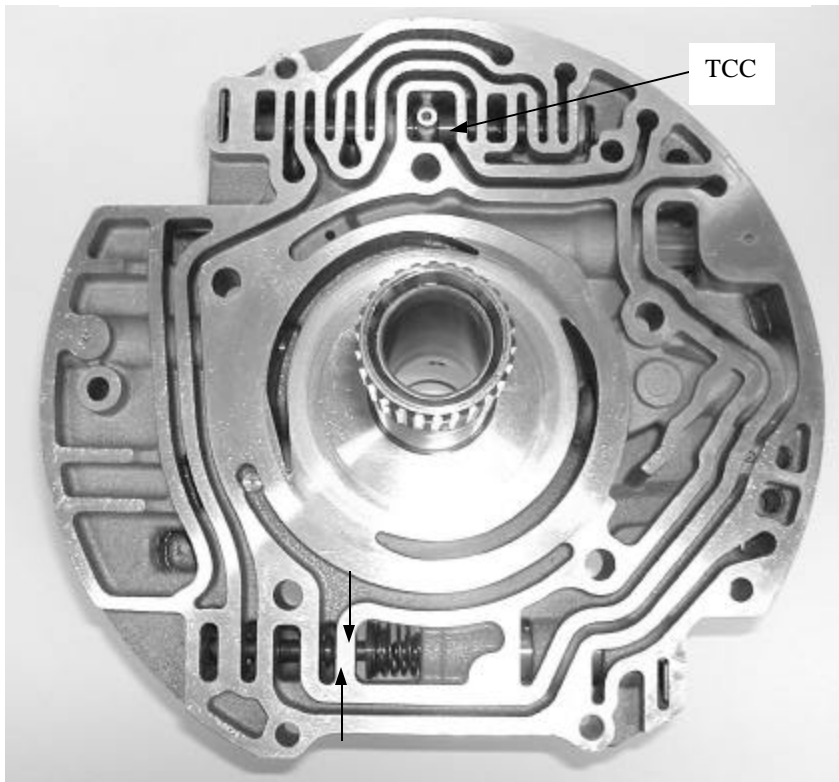
5L40E Pump pressure regulator

The bore for pressure regulator valve wears severely.

Prop the valve open approximately 1/32". It should not move in the bore.

Picture illustrates two valve modulated TCC design.

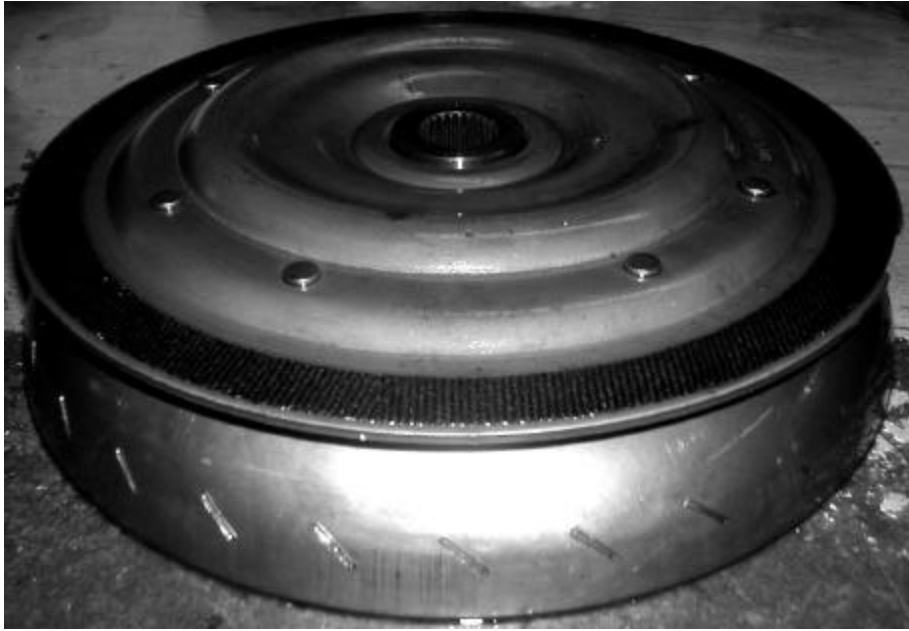
Piston Deflection Likely.
Two known pistons. Light weight/thinner pictured.
Look for loose rivets & cover contact. (above picture)

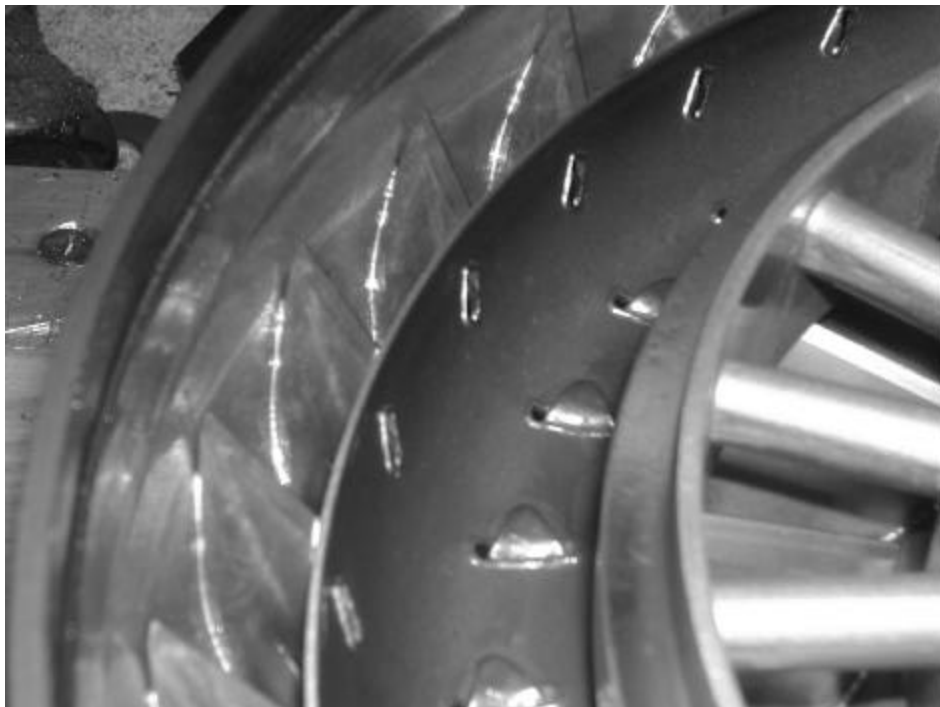
Check the impeller blades.
Noise and debris occur as the blades pull out.
This has been an issue on the BMW diesels.

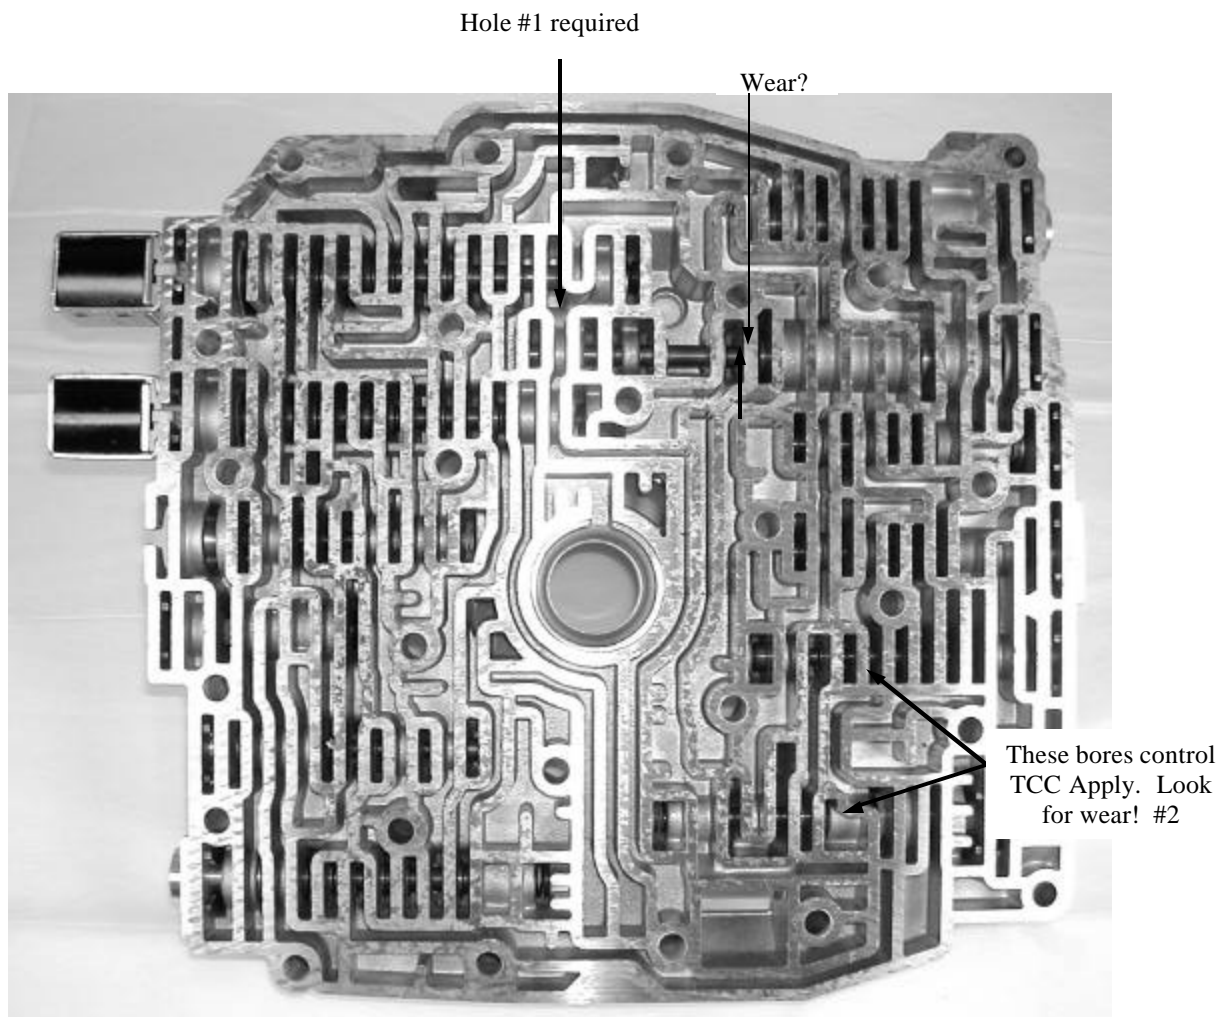
1. Main pressure regulator bore worn
2. Mis-matched separator plate, regulator valve does not have a balance hole. (see arrows at #1)
3. Filter may be plugged from converter lining. TCC lining may come loose from piston over pressurization or a poor bonding process at OE. Piston deflection can be caused by arrows #2.

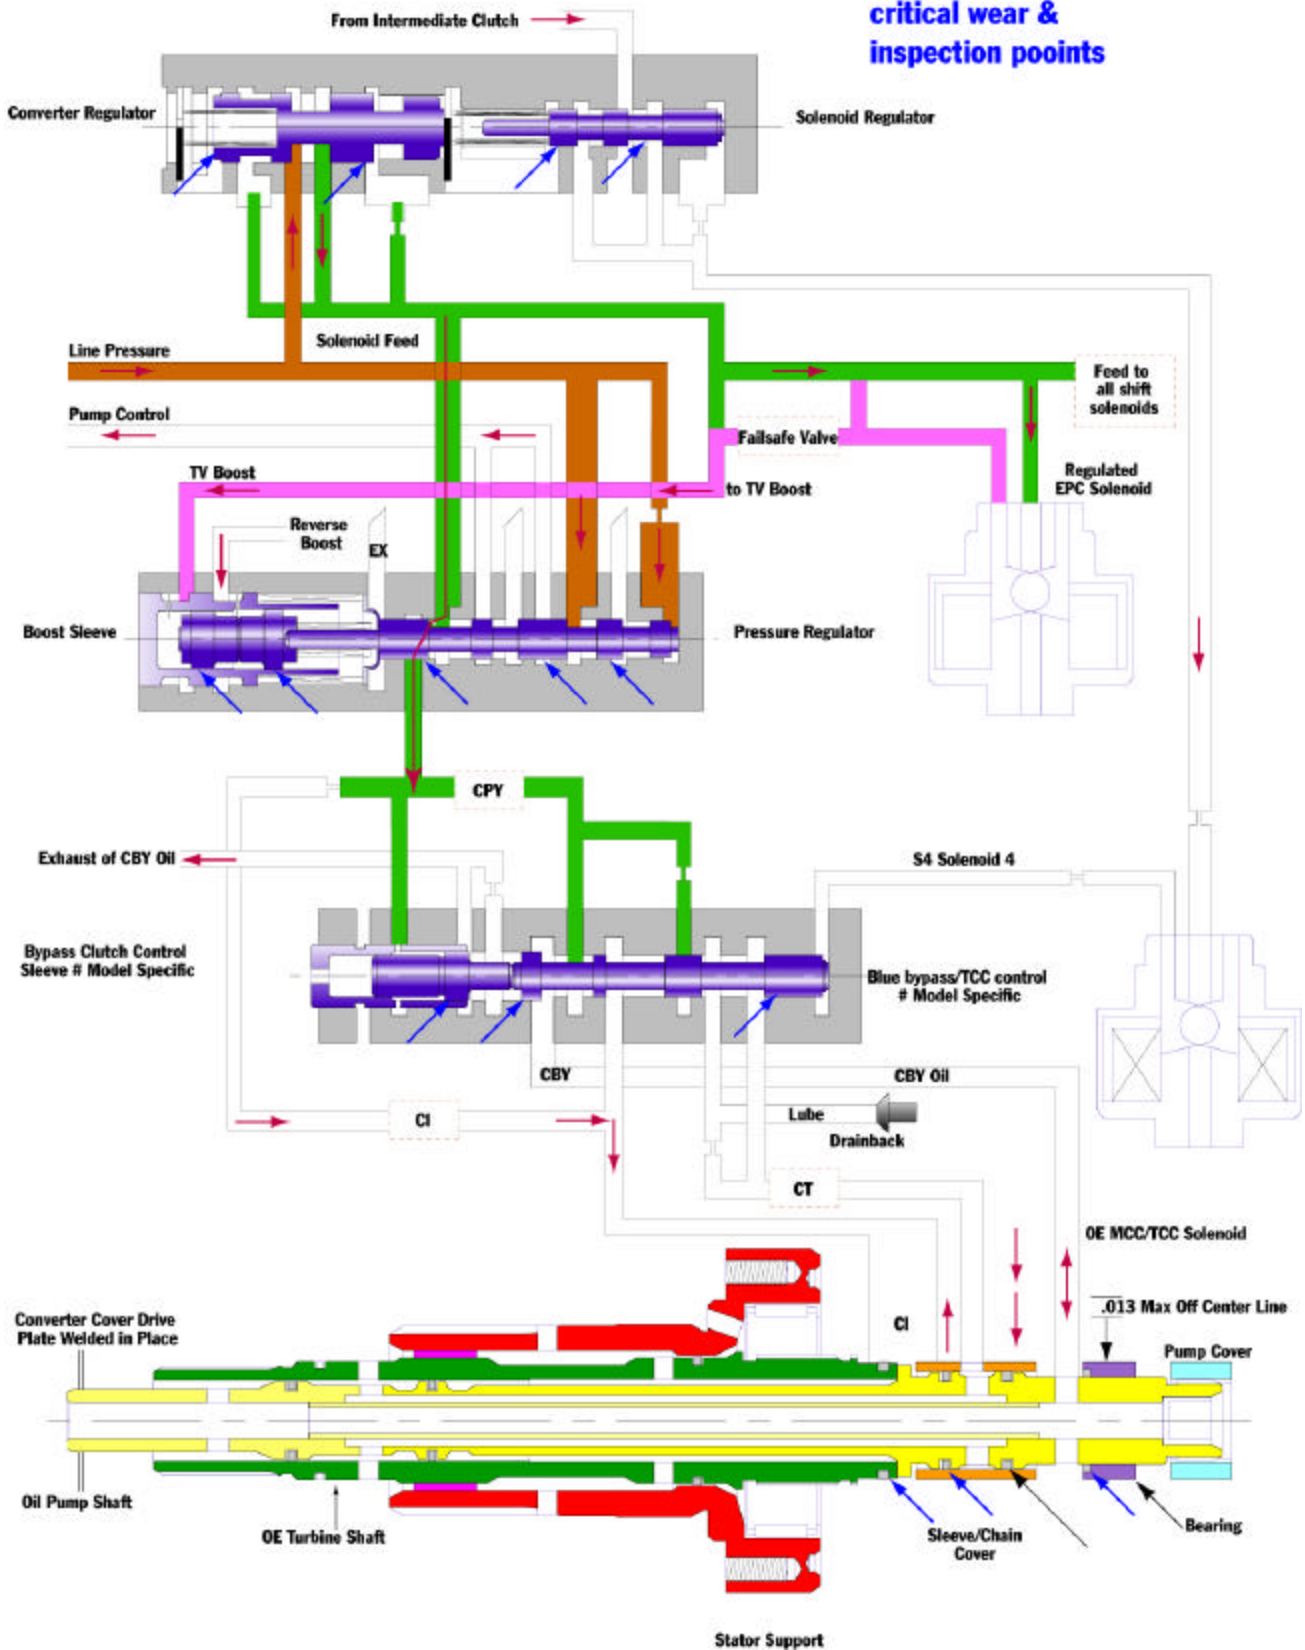
AX4S/AX4N

Blue arrows indicate critical wear & inspection points

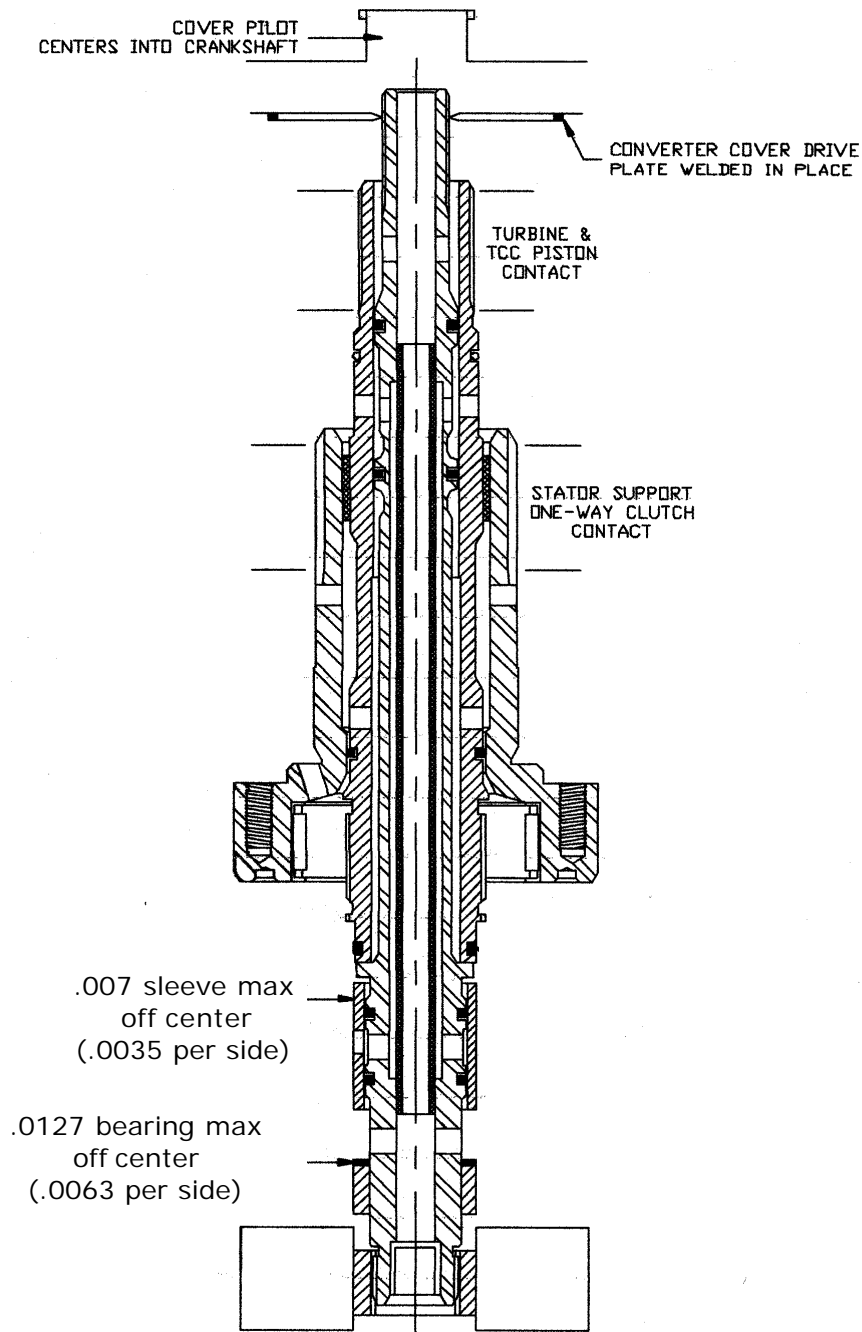
AX4S

Inspect the oil pump shaft for wear at the sealing ring grooves. Visible wear indicates the shaft is not running true. Insure the oil circuit flowing around the inner pressed tube is not restricted. Restriction here will increase converter pressure, which if severe enough will increase back-pressure on the seal. Restricted oil flow will also cause delayed engagement and TCC problems.

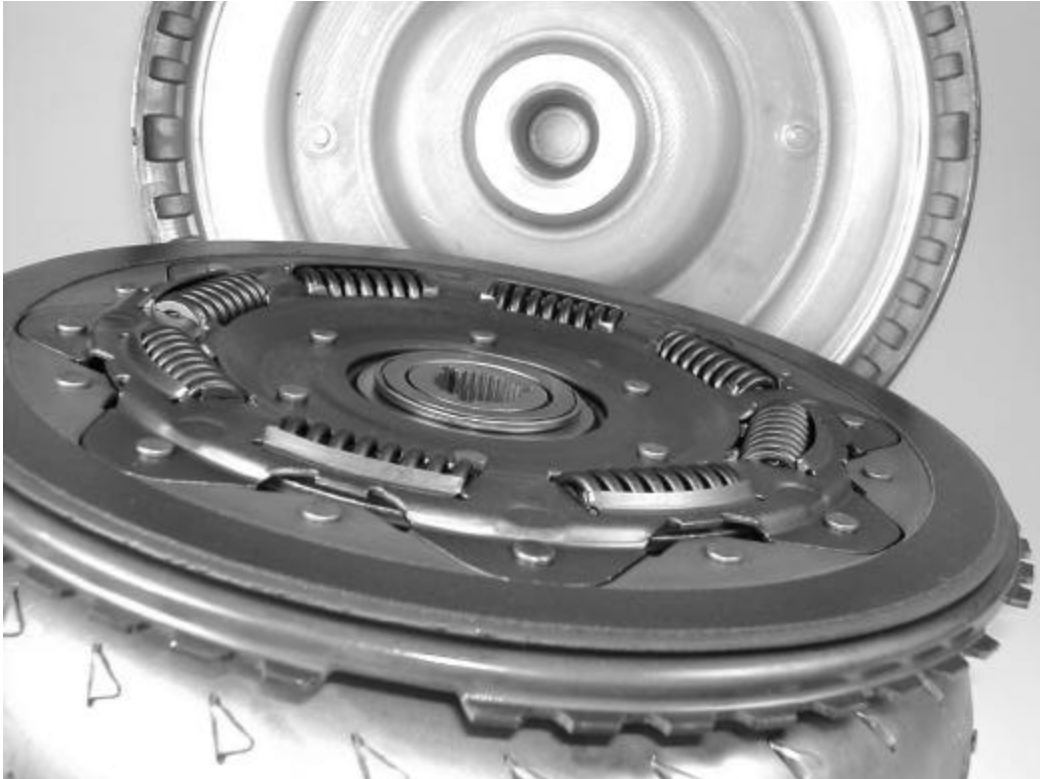
Multiplate converter with bearing turbine hub (ill. 1)

In the 4R100 converter example, the exhaust of fluid past the turbine hub controls the piston travel. If too close/ restrictive, the release oil will slowly exhaust as the TCC piston forces the oil out. (*ill. #1 4R100 multi-plate converter with bearing turbine hub*)

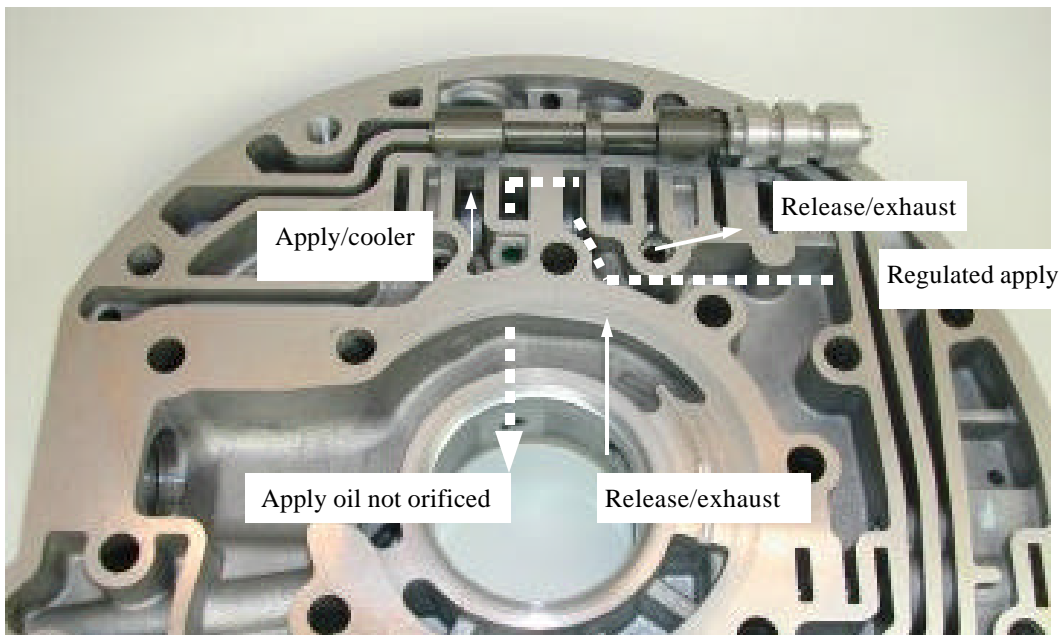
TCC modulated control valve (ill. 2)

On the modulated converter circuit of the 4R100, the fluid coming from the TCC regulator valve goes unrestricted to the converter apply piston. (*ill. # 2, Modulated 4R100 circuits*) As the TCC solenoid modulates the control valve, the release oil between the piston and the cover, exhausts without an orifice. The apply oil now gets priority toward the piston and is restricted toward the cooler direction.

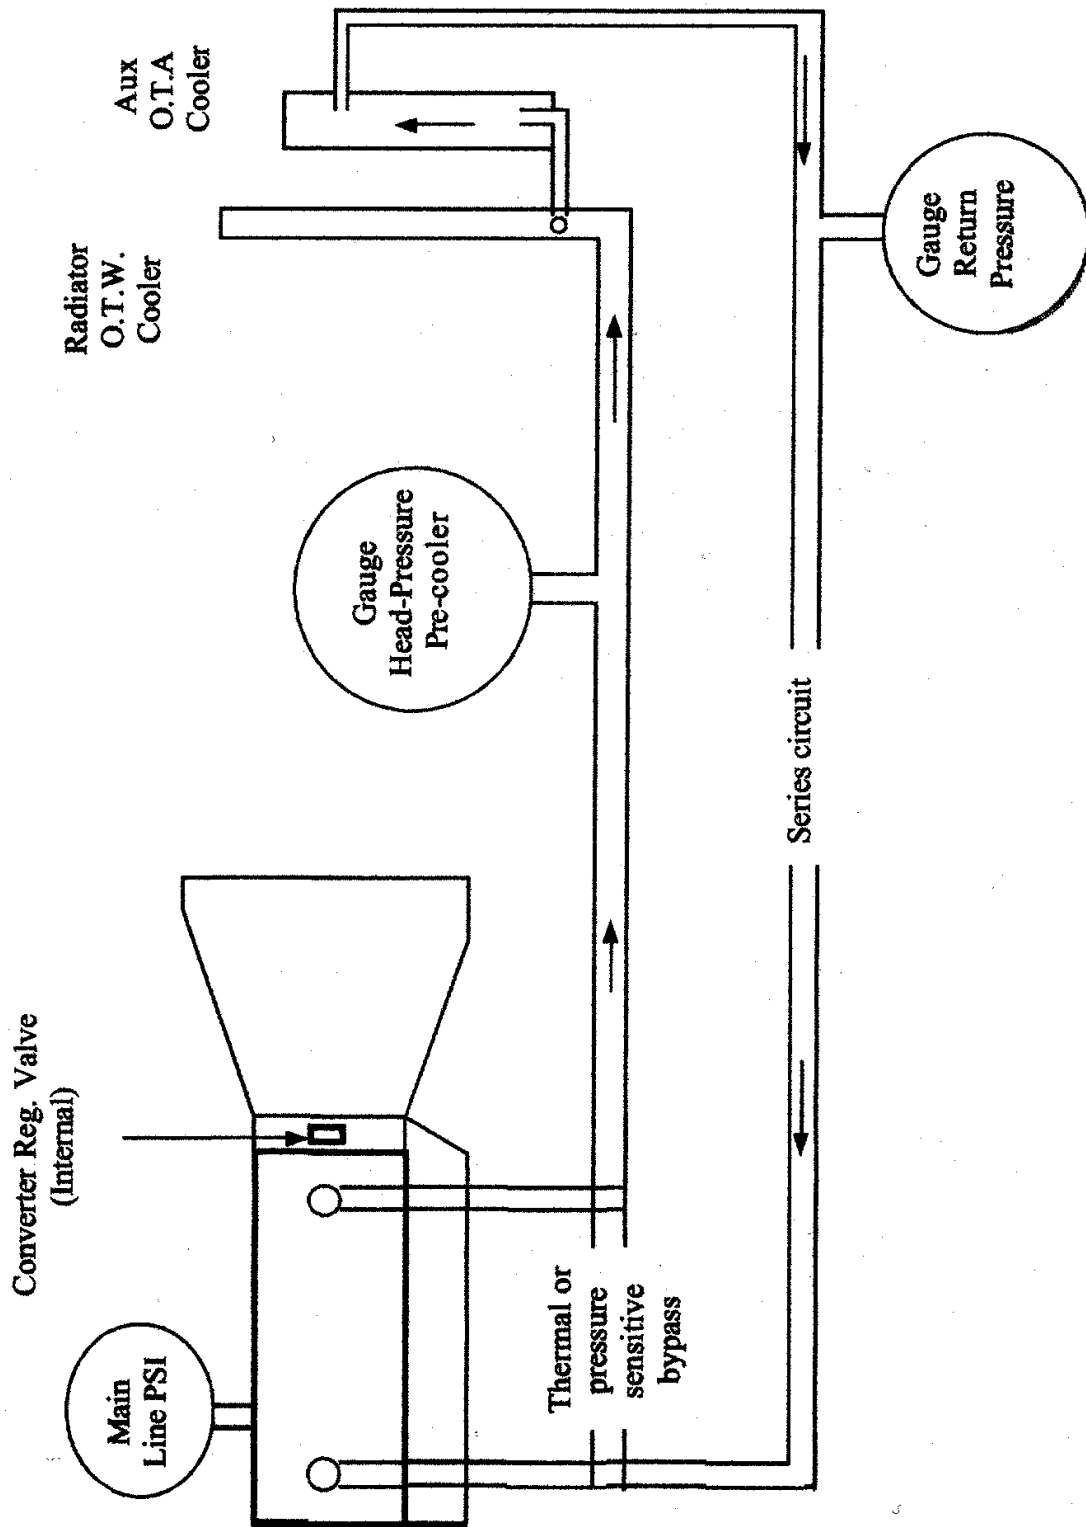
4R100 Cooler Pressure (ill. 3)

Checking cooler flow and head pressure at the same time is the best method to isolate if there is a problem. If you cannot monitor flow, at minimum check head pressure. (*ill#3, illustration of where head psi. is obtained*)

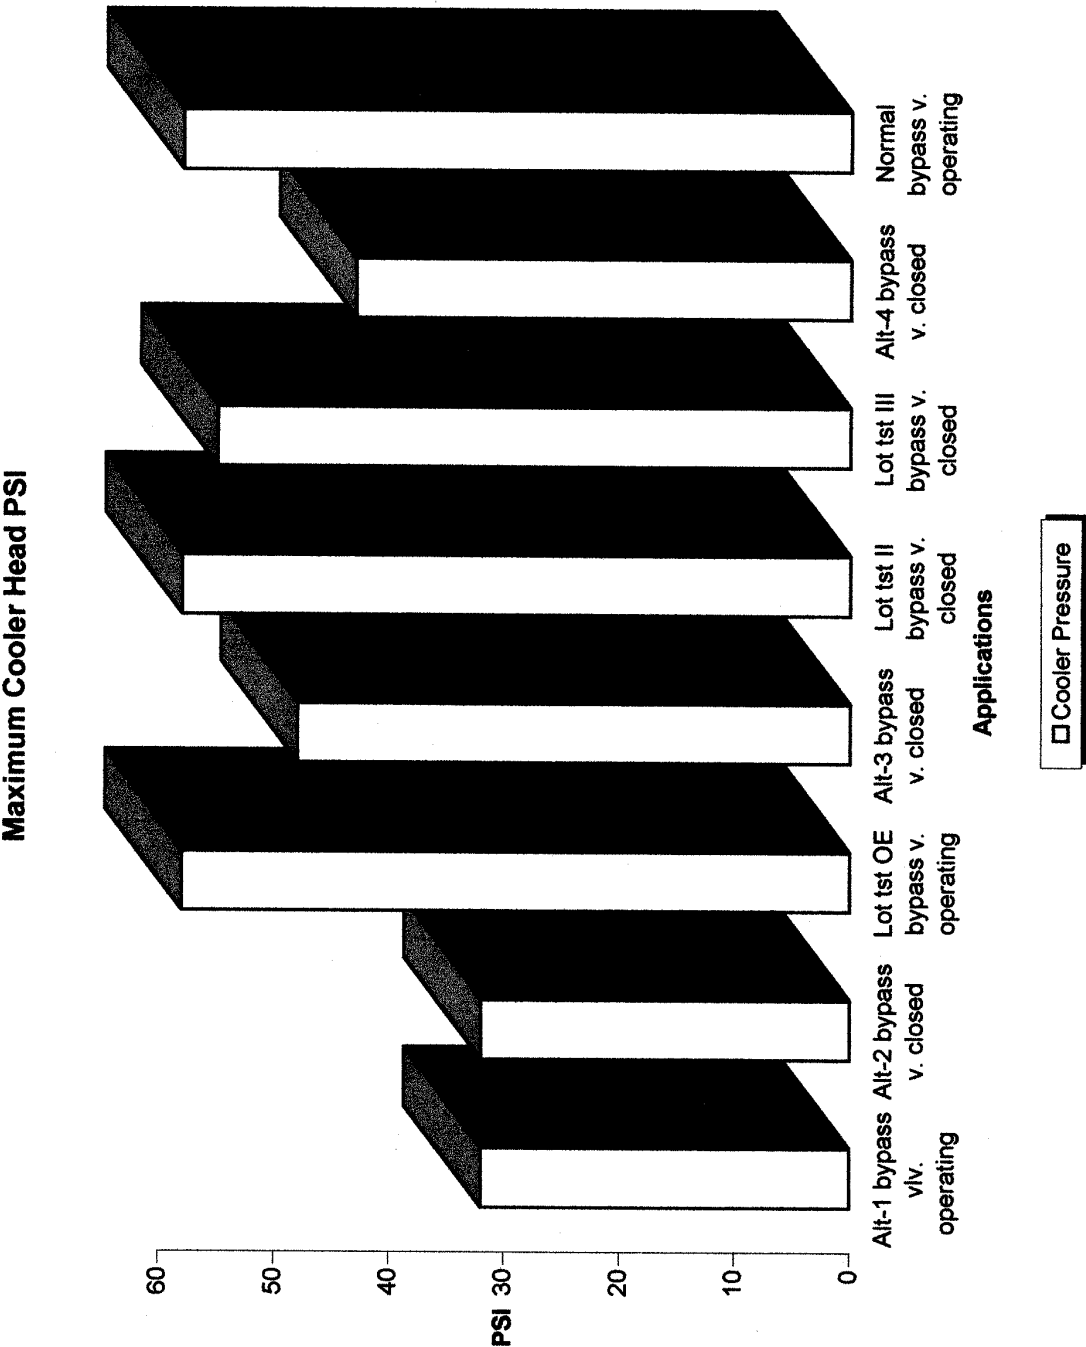
4R100 PSI (ill. 4)

On the 4R100 cooler test graph, note the two units Alt1 and Alt2. Both had restricted converters. (*ill#4 Excel graph*) There is minimal difference in flow (left side) during lockup and head pressure (right side) does not rise to normal. Normal specifications are shown on far right. The Lot test OE example is from pre-repair, with unrelated problem. The Alt4 test is using converter from Alt 1 and improving the oil flow, then installed into the same truck. Alt3 is a used OE converter installed into same Alt 1 truck. The other bar graphs are testing various stages with bypass closed or open to isolate it.

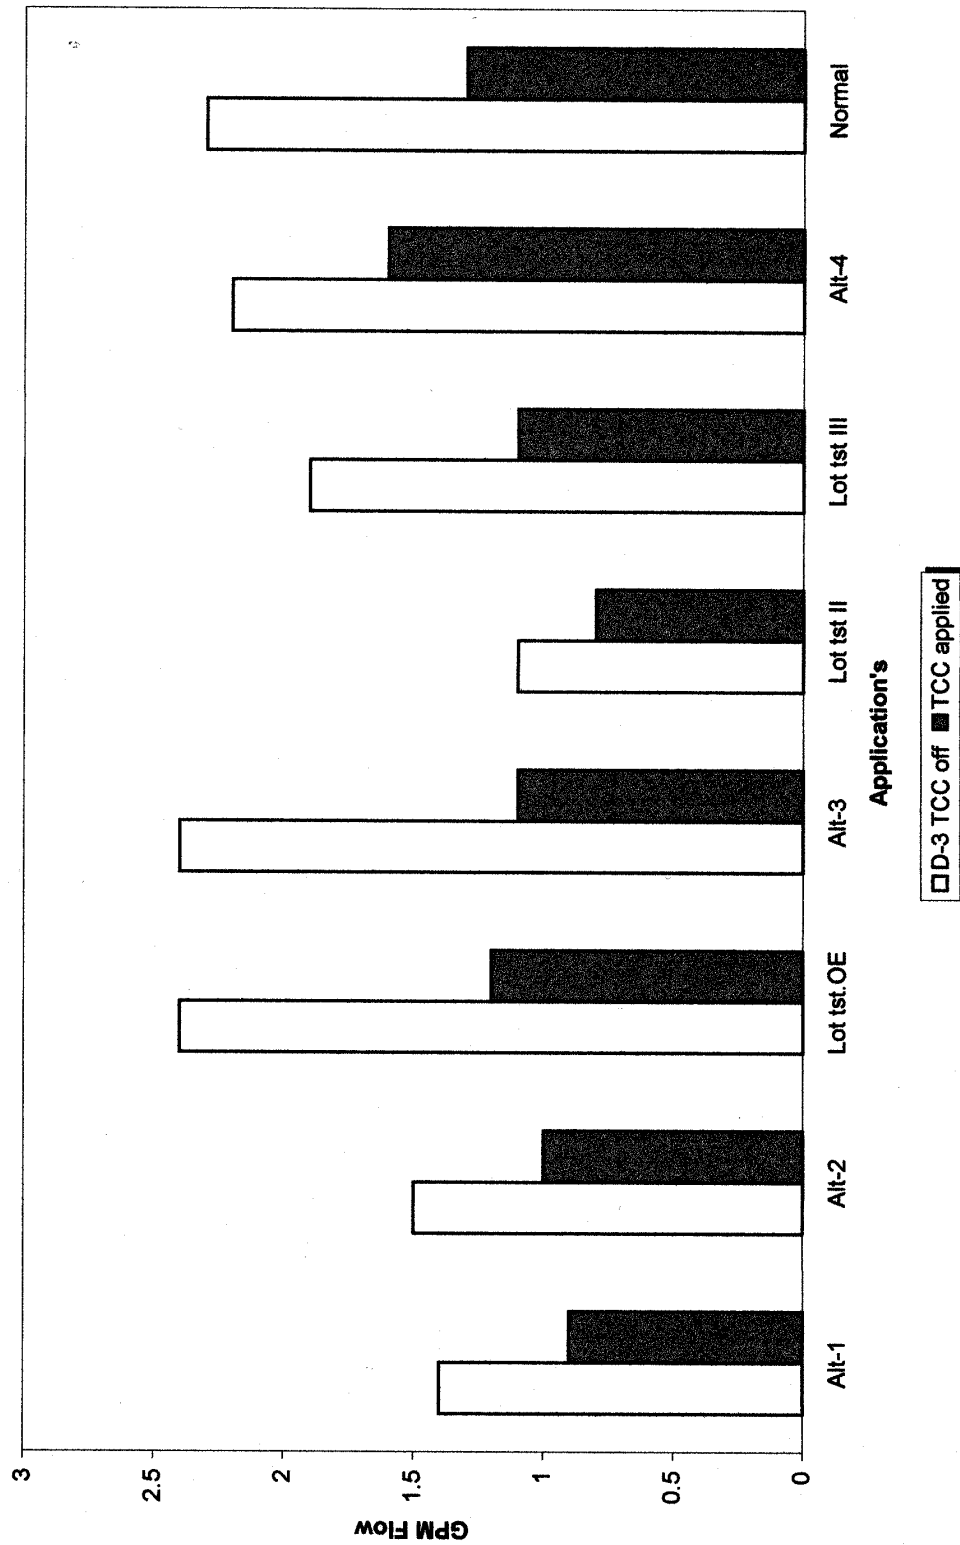
4R100 Maximum Cooler Flow (ill.4)

First test after code 1728
Original pump with TCC valve modifications
OE by-pass operational
Same converter type

New OE pump, no valve modifications
By-pass welded to prevent opening
Hotflush machine had 3.6 G.P.M.
Same converter type

Installed OE converter from Lot test OE into problematic vehicle.
By-pass welded closed
TCC apply very good

Installed converter from Alt-1 opened and modified to increase flow.
Installed into a 3rd truck
By-pass welded closed
