TCRA

Latest Trends in Tech Support

May 12, 2006

***Presented by;
Bob Warnke***

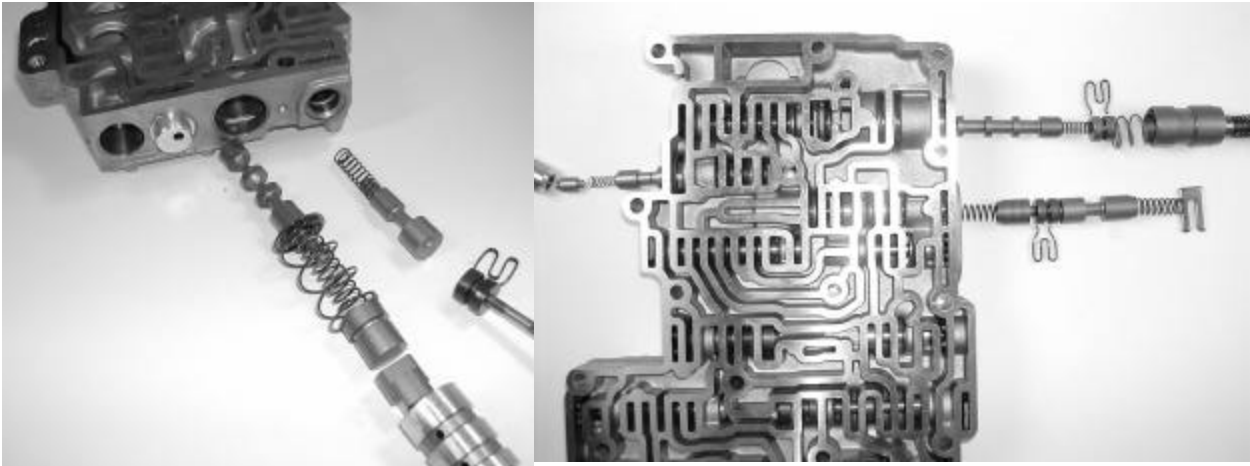
Cause:

Valve bodies are known to wear at comparatively low Mileage. (50,000 mi.)

For TCC slippage, look at the TCC modulator bore, inner valve. This controls TCC slip rate via the outer sleeve & TCC solenoids. Inspect outer sleeve for wear.

For TCC over-pressurization, look at pressure regulator bore wear or altered/stronger main regulator spring.

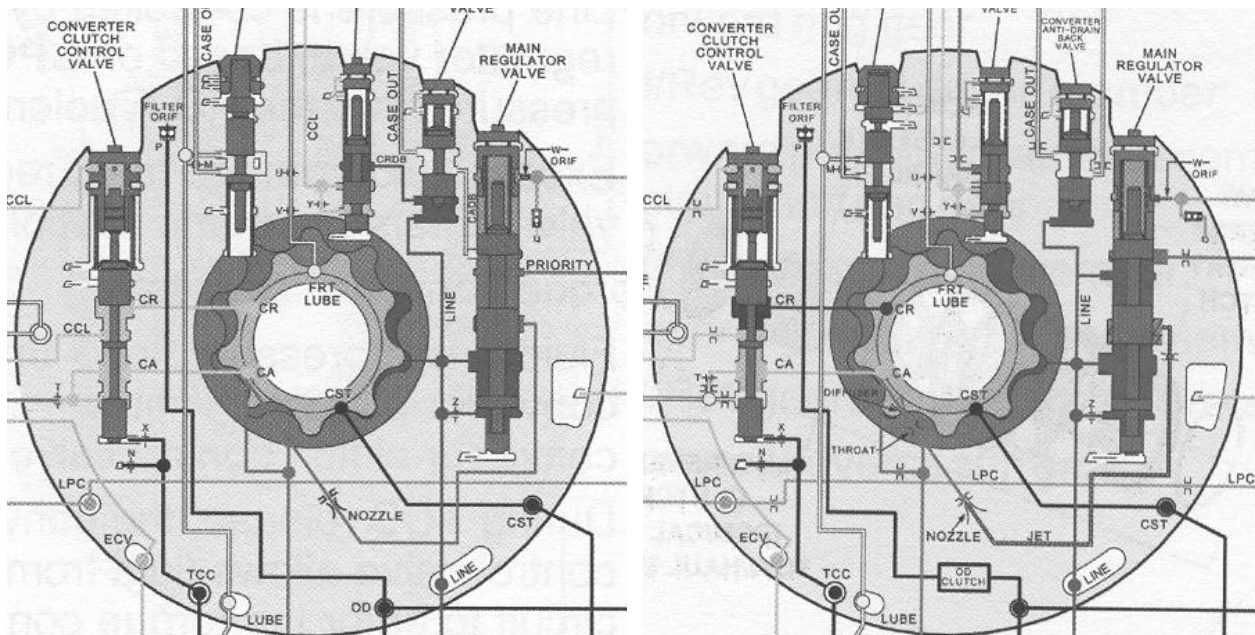
Cause:

- Pump capacity low
- Sticking thermal cooler by-pass valve
- Worn converter regulator sleeve
- Excessive flow restriction within converter cooler restrictions.

OE cooler flow requirements are tested warm and hot, at idle in park.

- 110 degrees F = 1 gal. per minute or 8 ozs. 15 seconds.
 - 180 degrees F = 2 gal. per minute or 64 ozs. 15 seconds.
- (Spec's courtesy of John Parmenter)
